# Major Debris Disaster Cases Express – Other, 2015

## Nantou County—Chingying Village, Ren'ai Township

### Chingying Village, Ren'ai Township

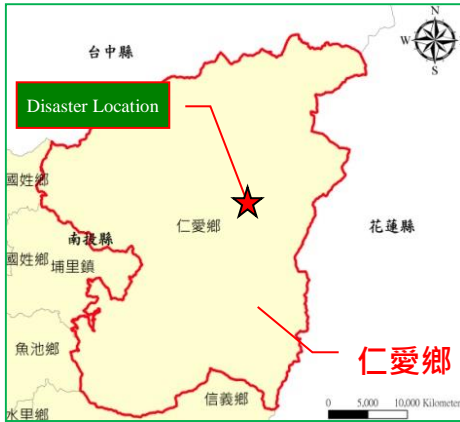
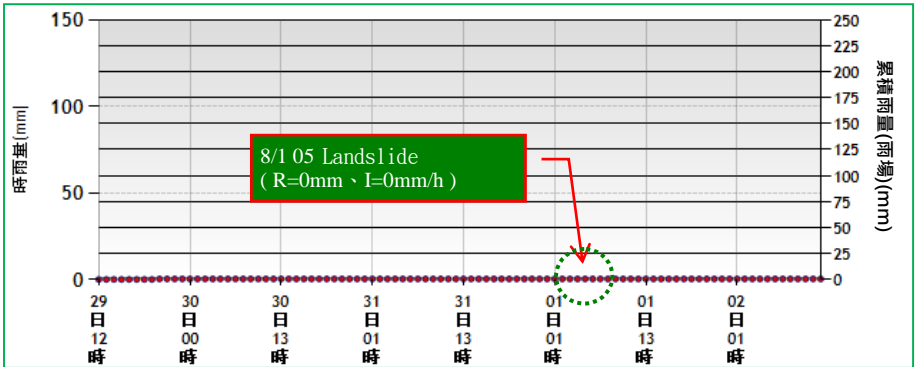
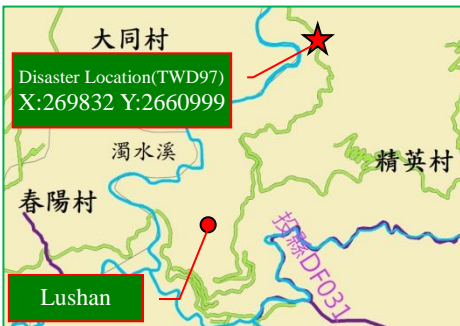
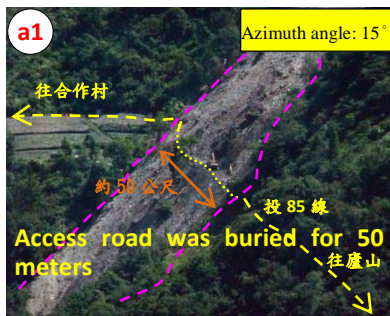
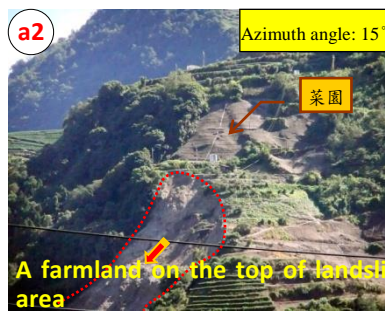
- ❖ Disaster Location : 7K at Provincial Highway 85
- ❖ Disaster Time : 05:00, Aug, 1<sup>st</sup>
- ❖ Disaster Type : Collapse
- ❖ Accumulated Rainfall : 0 mm

Provincial Highway 85 is the main access for Hetzuo Village. There started to take place some small-scale landslide around 7K of Provincial Highway 85 from July. On 5:00, August 1<sup>st</sup>, it extended to a large-scale landslide. The debris buried the access road for 50 meters where interrupted the traffic and 2000 residents were affected. The landslide area was 7500m<sup>2</sup> with 45000m<sup>3</sup> debris.
