# Major Debris Disaster Cases Express – Other, 2015

## Taoyuan City— Kuihui Village, Fuxing Dist

### Kuihui Village, Fuxing Dist -001

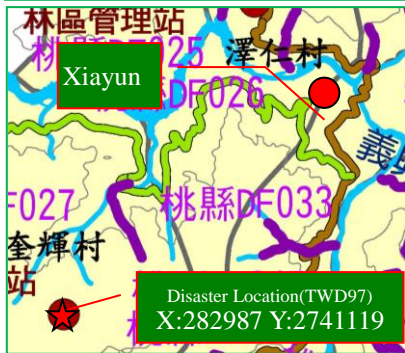
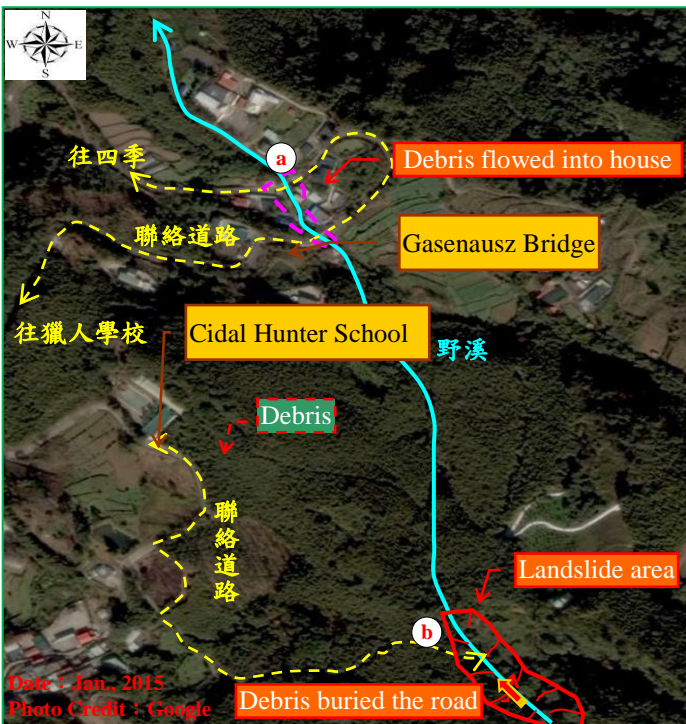
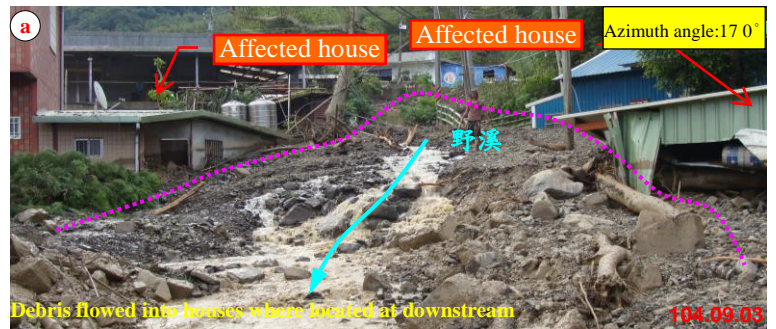
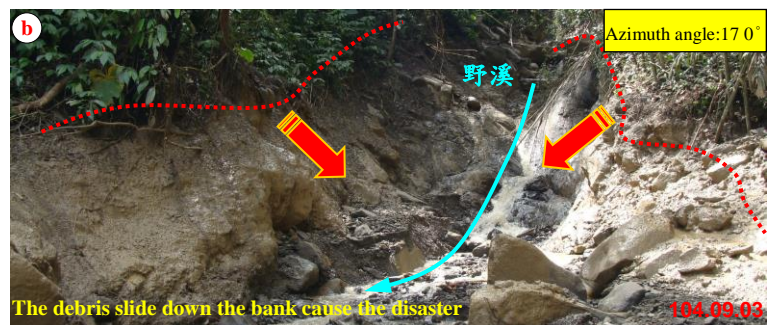
The circulation of Typhoon Soudelor brought lots of precipitation in Nantou. A debris flow took place at upstream of Gasenausz Bridge. The debris overflowed the channel and flowed into houses.

After a pouring rain on Sep. 2<sup>nd</sup>, the debris on the upstream slid down the channel again. One landslide area is about 1800m<sup>2</sup> buried with 3600m<sup>3</sup> debris. The debris buried the bridge for 10 meters and the road lost its foundation for 5 meters.
